Prüfbericht - Nr.: <i>Test Report No.:</i>	28105326 001	Seite 1 von 16 <i>Page 1 of 16</i>	
Auftraggeber: <i>Client:</i>	VEIGROUP Srl Piazza G.Zanella, 1/A - 36066 Sandrigo (VI) - Italy		
Gegenstand der Prüfung: <i>Test item:</i>	On-board weighing system		
Bezeichnung: <i>Identification:</i>	HELPER X MILLENNIUM 5	Serien-Nr.: <i>Serial No.:</i>	S/N 26.06256 Dust test S/N 26.06255 Climatic and salt test S/N 25.09860 Vibration test
Wareneingangs-Nr.: <i>Receipt No.:</i>	299	Eingangsdatum: <i>Date of receipt:</i>	15 th June 2012
Zustand des Prüfgegenstandes bei Anlieferung: <i>Condition of test item at delivery:</i>	As delivered by the customer		
Prüfört: <i>Testing location:</i>	TÜV Rheinland Italia S.r.l. Via Mattei, 3 - 20010 Pogliano Milanese (MI) - Italy		
Prüfgrundlage: <i>Test specification:</i>	SAE J1455 rev. 2012		
Prüfergebnis: <i>Test Result</i>	Der Prüfgegenstand entsprichtoben genannter Prüfgrundlage(n). <i>The test item passed the test specification(s).</i>

TEST REPORT	
Test procedure for Environmental testing	
Report Reference No.	28105326 001
Date of issue	23 rd August 2012
Total number of pages	16
Testing Laboratory	TUV Rheinland Italia S.r.l.
Address	Via Mattei, 3 -

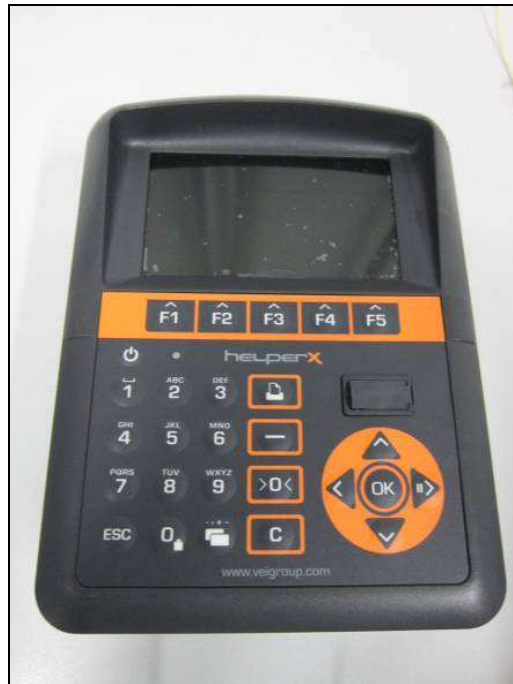
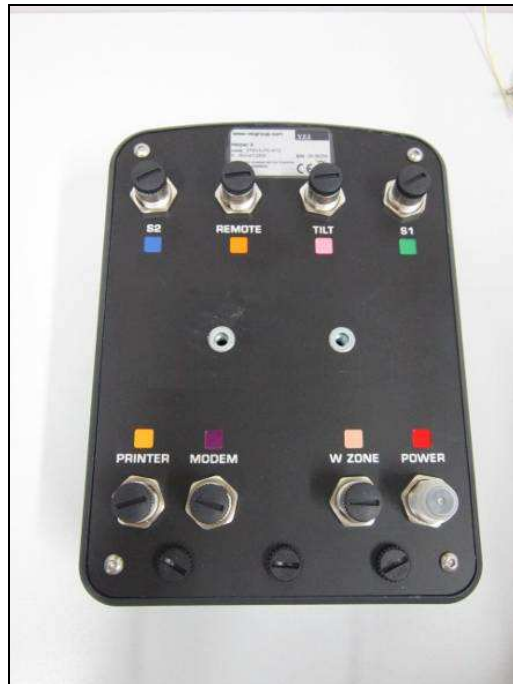
Fig. 1 Samples without printer

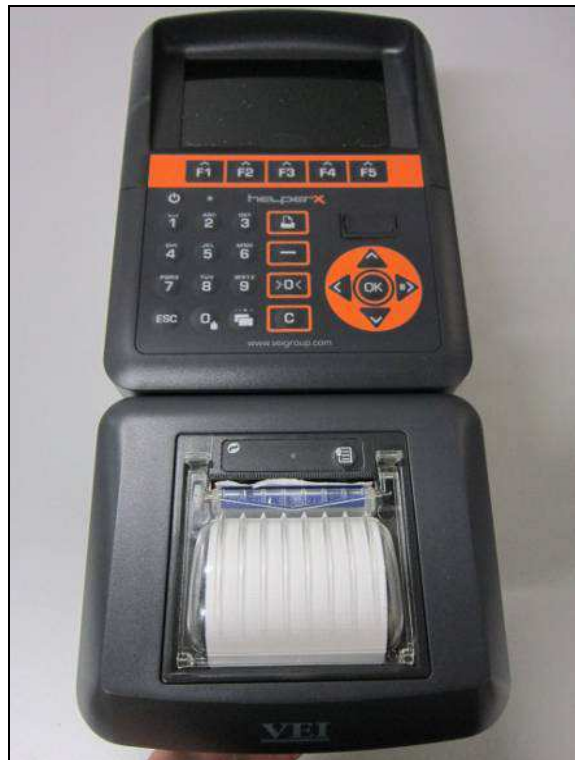
Fig. 2 Samples with printer

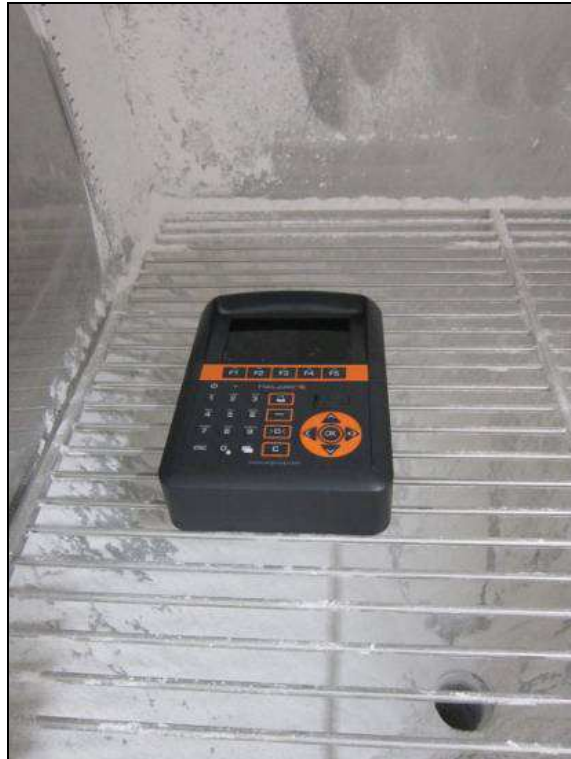
Fig. 3 Sample in dust chamber

<u>Tests and results:</u>		
Clause	Requirement + Test	Verdict
§ 4.7.3	General requirement: dust test	
	<p>The sample is subject to the test in the same condition of IP5X test in accordance with DIN 40050-9.</p> <p>The talcum powder used shall be able to pass through a square-meshed sieve the nominal wire diameter of which 50µm and the nominal width between wires 75µm. The amount of talcum powder to be used is 2kg.</p> <p>The enclosure under test is supported inside the test chamber. Any drain-hole normally open shall be left open for the duration of the test.. Every 55s, the dust flows in the chamber for 5s. The test shall be continued for a period of 8h</p> <p>The talcum powder shall not accumulate in a quantity or location such that it could interfere with the correct operation of the equipment or impair safety. No dust shall deposit where it could lead to tracking along the creepage distances</p>

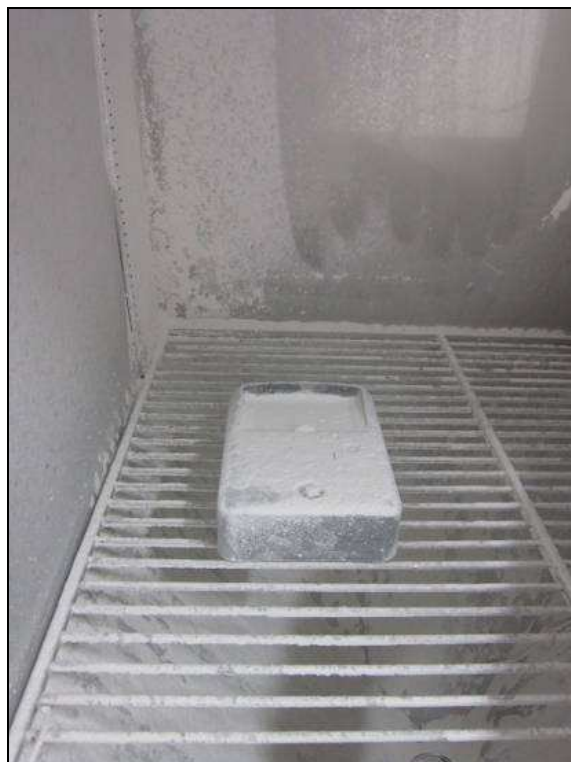
Fig. 4 Samples in the chamber after dust test

Final measurements	
	There is some dust inside the sample, but not on live parts.	P

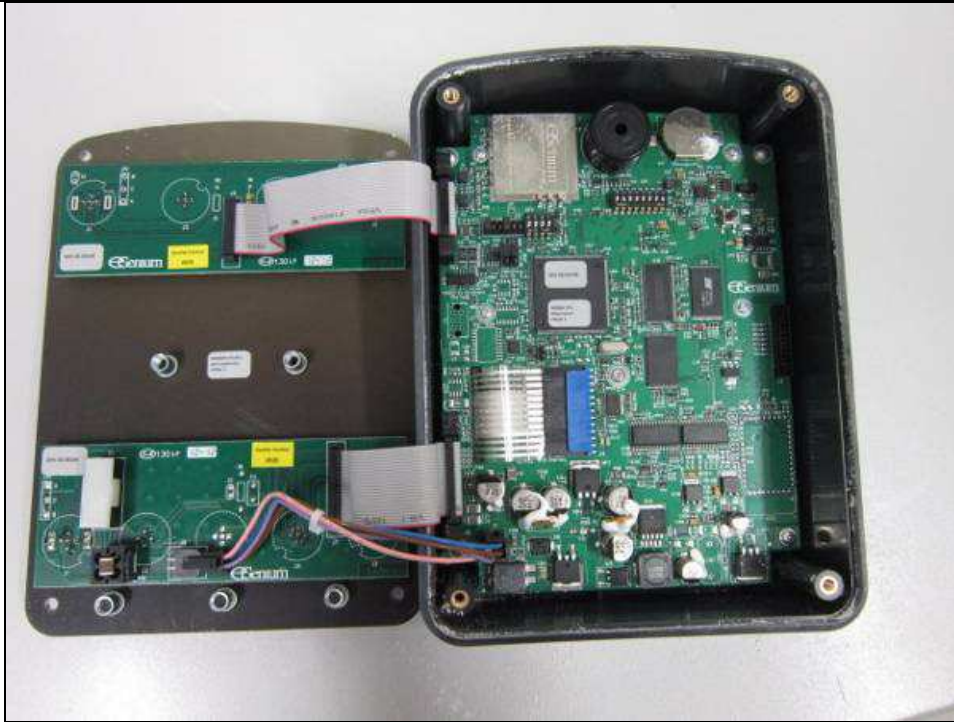
Fig. 5 Samples during the visual inspection after dust test

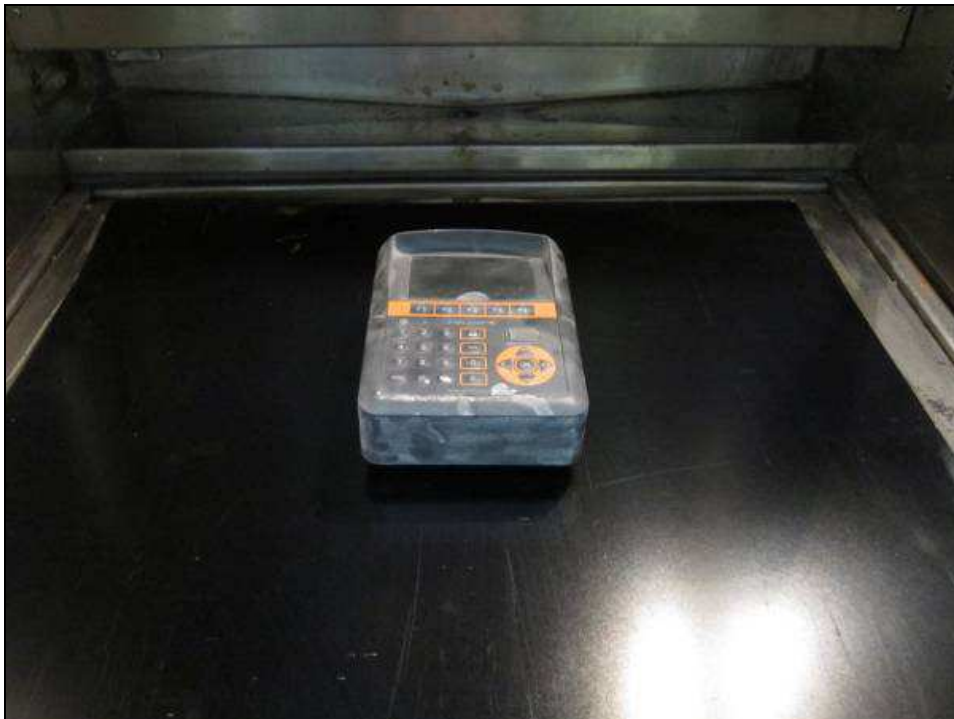
Fig. 6 Sample in the climatic chamber

<u>Tests and results:</u>		
Clause	Requirement + Test	Verdict
§4.12.3	General requirement: climatic test	P
	<p>The sample is subject to the climatic test shown in Fig.15, with the following characteristics:</p> <ul style="list-style-type: none"> ○ initial temperature: 25°C ○ T_A: Minimum temperature -40°C ○ t_1: 150min ○ T_B: Maximum temperature 85°C ○ time to change from T_A to T_B 30min <p>Cycle repeated for 96h</p>

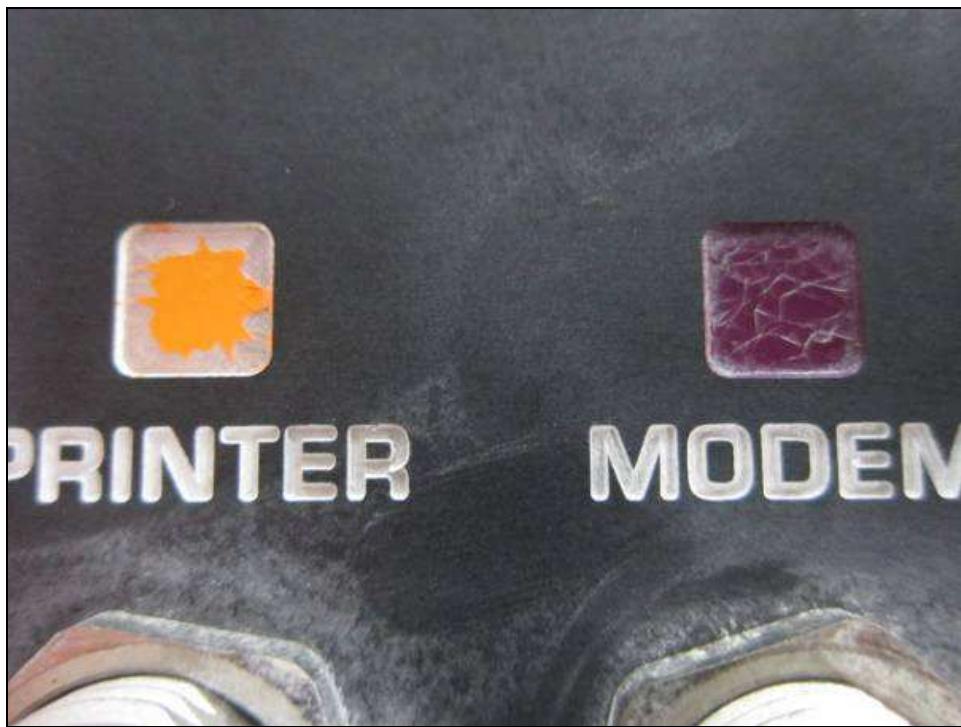
Fig. 7 Coloured labels after the climatic test

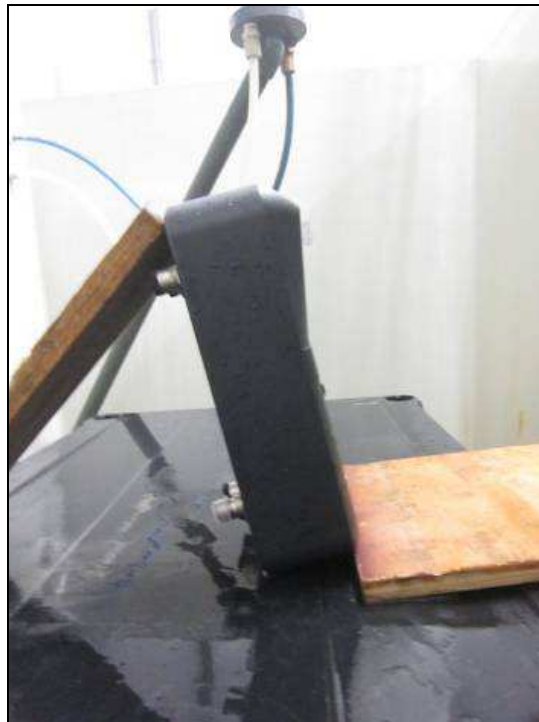
Fig. 8 Positioning of the sample inside the salt mist chamber

<u>Tests and results:</u>		
Clause	Requirement + Test	Verdict
§ 4.3.3.1	General requirement: salt mist test	P
	<p>The sample is exposed to a solution of 5 parts salt to 95 parts water, atomized at a temperature of 35°C. The device is exposed to the salt mist for a period of 240h.</p> <p>When the test is concluded, the sample should be evaluated for visual evidence of salt precipitation or accumulation. The sample is gently rinsed in clean running water and then immediately dries with compressed air.</p> <p>Minimal traces of corrosion should be allowed (see from Fig.8 to Fig.12)</p>	
	Final measurements	
	There is only a small area of corrosion on one of the threaded insert	P

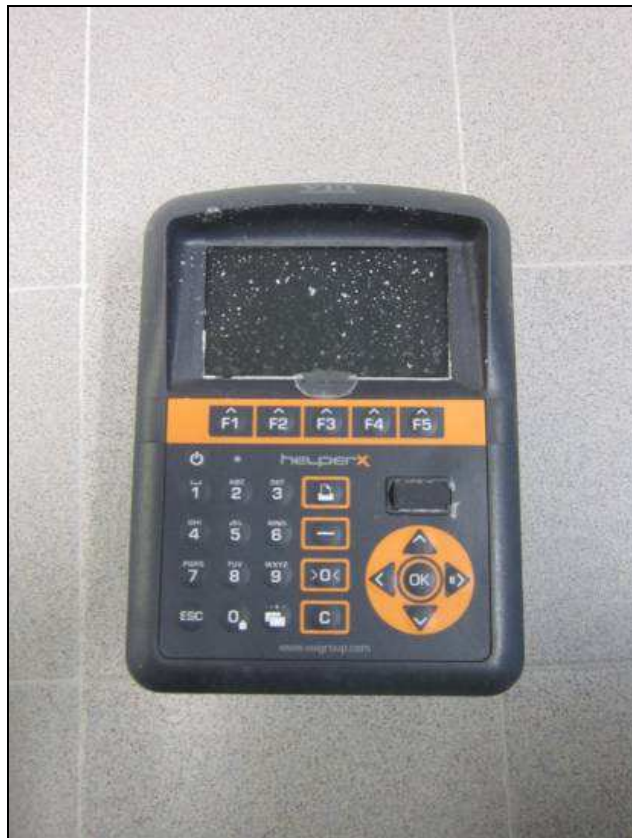
Fig. 9 Sample after salt mist test

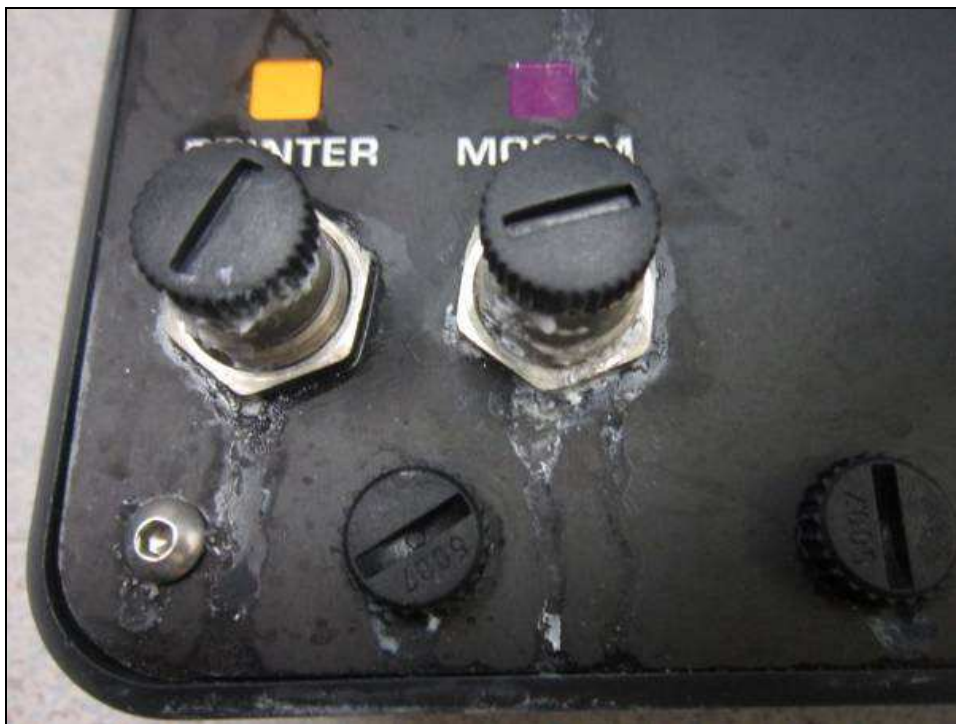
Fig. 10 Particular of the connectors on the rear side of the sample

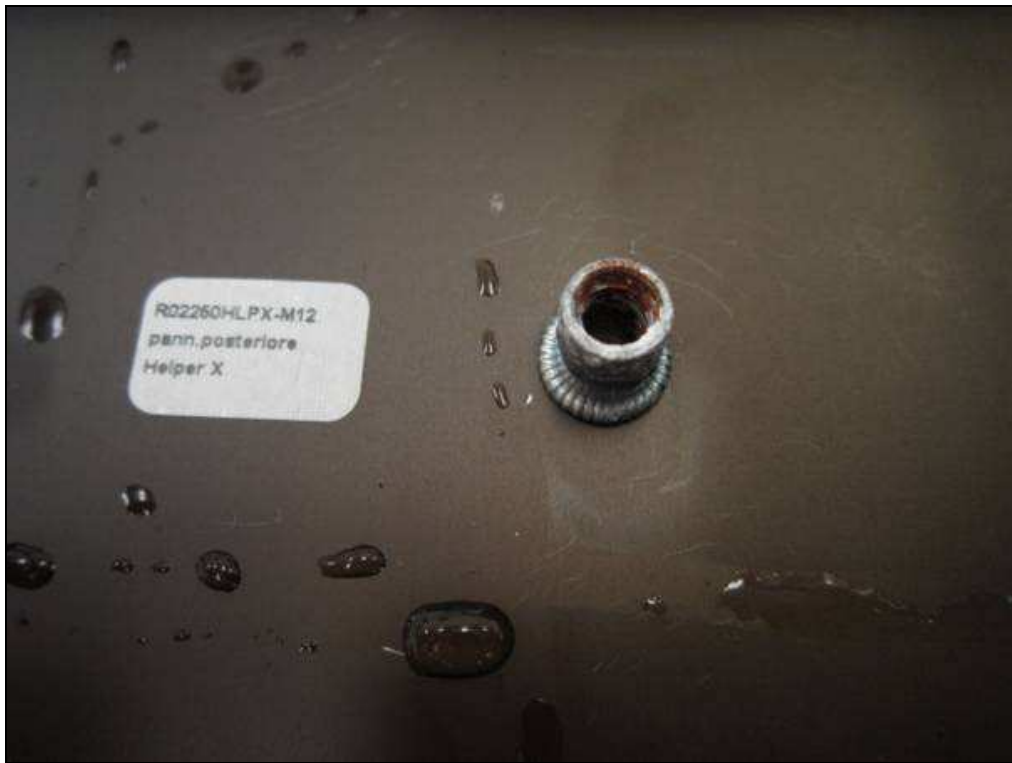
Fig. 11 Threaded insert inside the sample

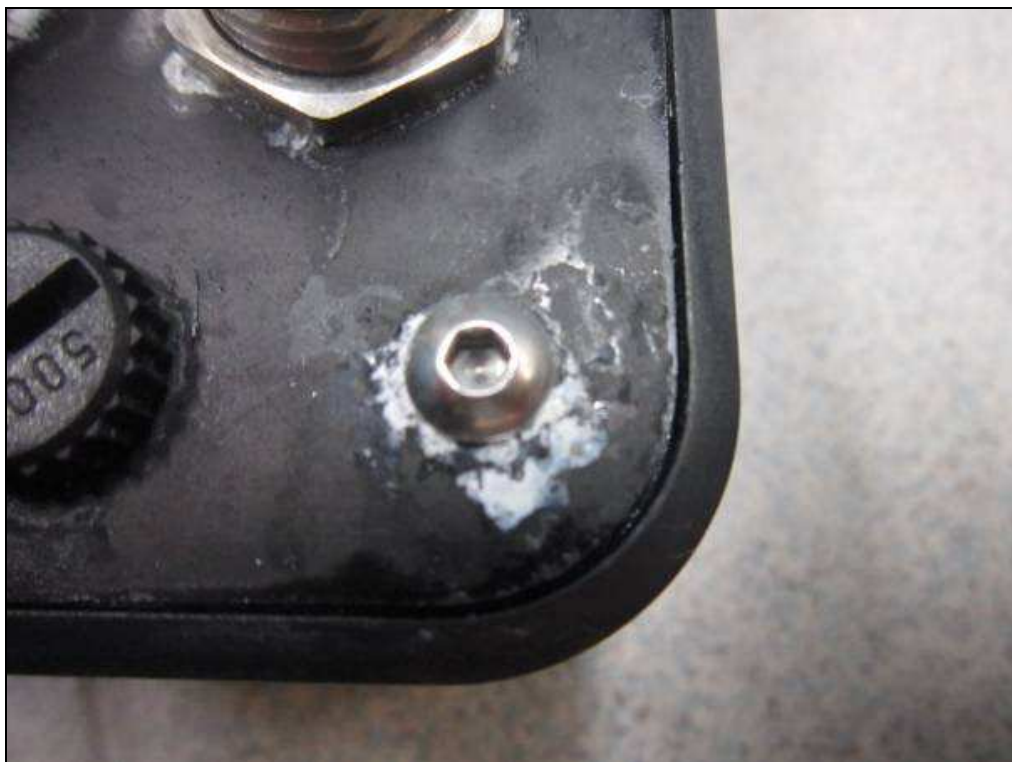
Fig. 12 Particular of the screw for the fixing of the cover

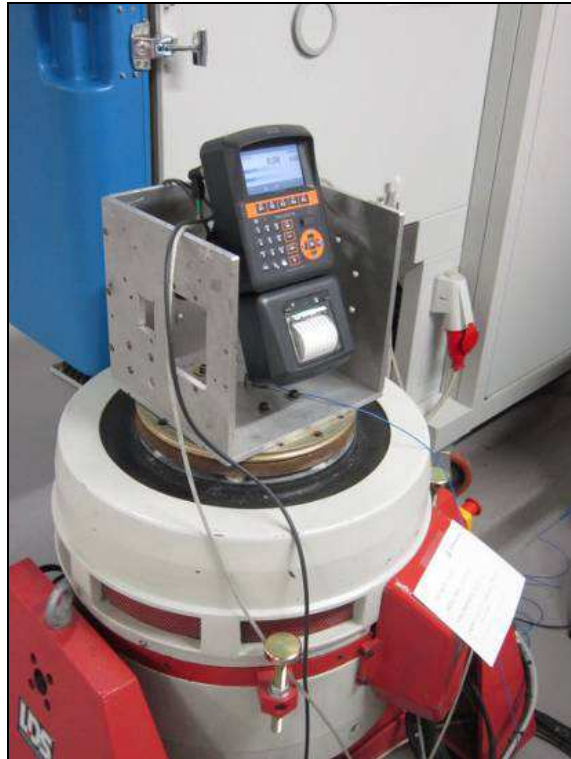
Fig. 13 Sample on the shaker

Tests and results:		
Clause	Requirement + Test	Verdict
§ 4.3.3.1	General requirement: vibration and shock test	P
	<p>The sample with printer, blocked on the fixture, is put on the shaker and subject to the vibration profile shown in the Fig.16</p> <p>Duration of the test: 3h</p>

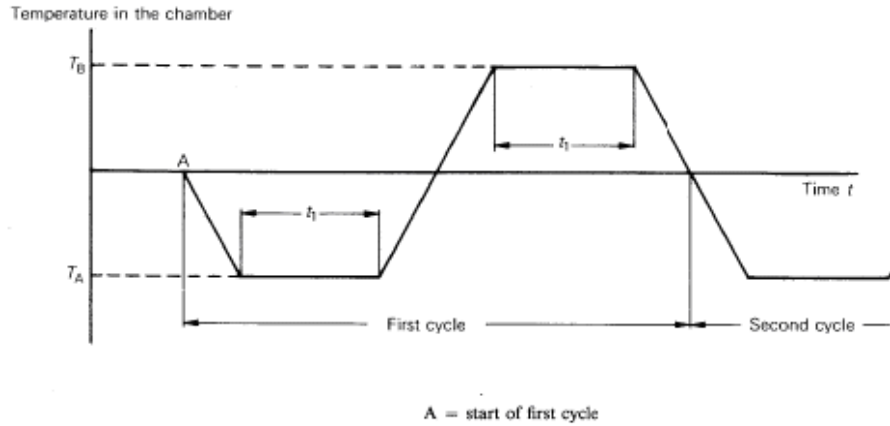
<p style="text-align: center;">A = start of first cycle</p> <p style="text-align: center;">Fig. 15 Graph of the applied climatic cycle</p>	
	Final measurements	
	After the test the sample does not present any defect	P

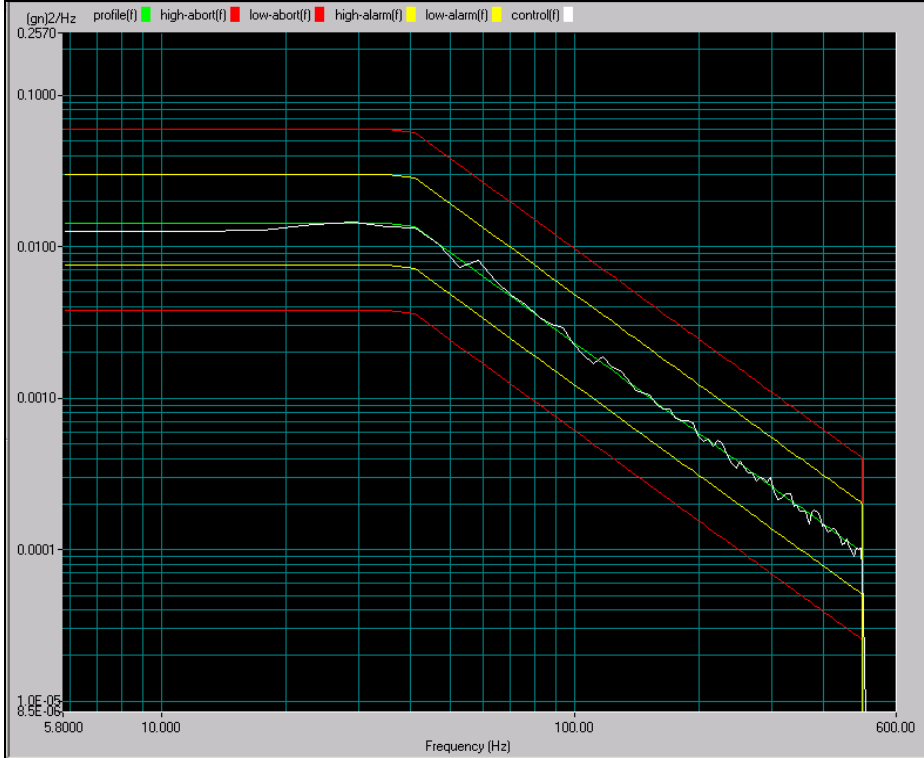
<p style="text-align: center;">Fig.16 Vibration profile</p> <p>The sample is powered in both the tests. The power supply is 12V</p>	
	Final measurements	
	The sample after the test does not present any deformation or visual defect and it is well-functional	P

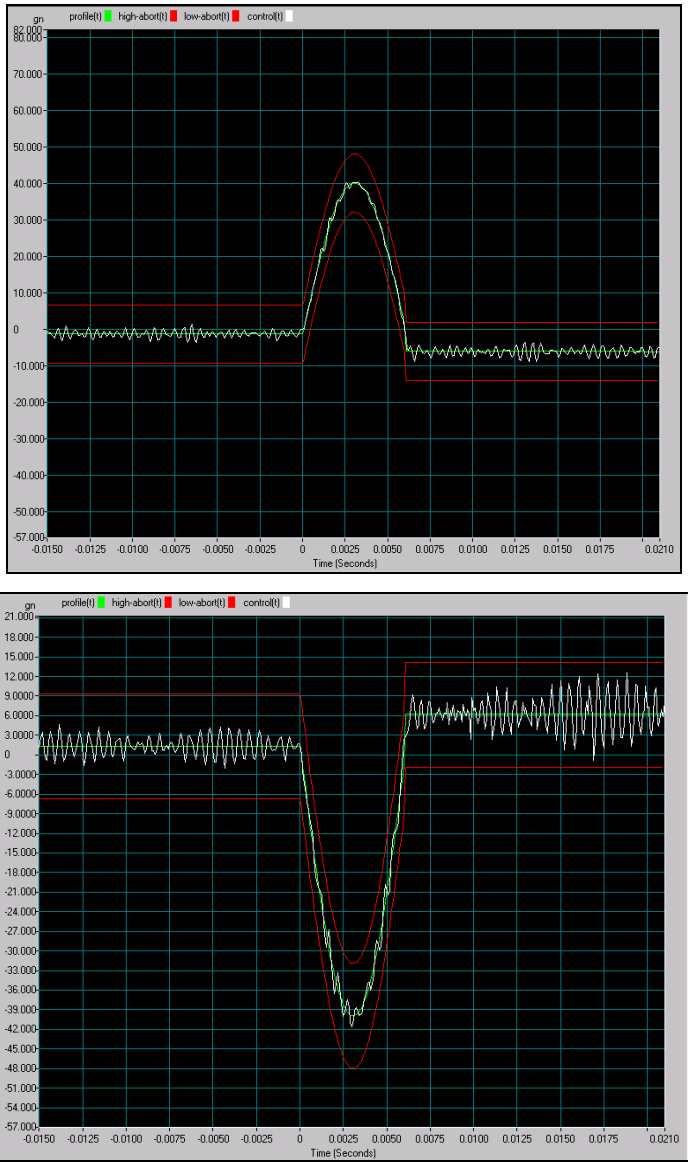
Tests and results:		
Clause	Requirement + Test	Verdict
§ 4.3.3.1	General requirement: Shock test	P
	<p>The sample with printer, blocked on the fixture, is put on the shaker and subject to 10 positive and 10 negative shock (see the profile in Fig.17)</p>

<p>Fig.17 Positive shock and negative shock profiles</p> <p>The sample is powered in both the tests. The power supply is 12V</p>	
	Final measurements	
	The sample after the test does not present any deformation or visual defect and it is well-functional	P
